The Cyanide Spill at Baia Mare, Romania

BEFORE, DURING AND AFTER

This is a summary of the UNEP/OCHA *Report on the Cyanide Spill at Baia Mare, Romania*. The report followed a joint investigative mission to the affected areas and was carried out by a team of 20 scientists during the period February 23 to March 6, 2000. It included sampling analysis and discussion with local authorities and NGOs in the affected areas. The brochure is divided into three main sections: (1) background information; (2) an assessment of the spill; and (3) recommendations for the future. If you need more information about any of the issues covered in this brochure, please use the contacts provided on page 8. This brochure is also available in Romanian, Hungarian and Serbian.

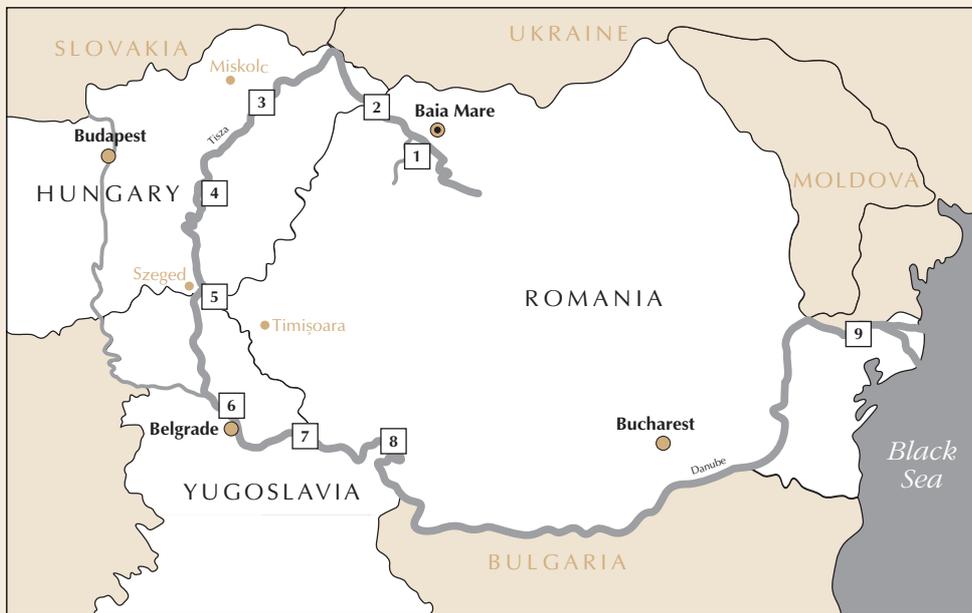
Spread of the cyanide spill from Baia Mare, Romania

Progress of the spill plume

- 1 30 January**
Cyanide spill occurs at Baia Mare, Romania
- 2 1 February**
Spill plume reaches Romanian-Hungarian border
- 3 5 February**
Cyanide registers in tests at Tiszalök
- 4 9 February**
Spill plume reaches Szolnok
- 5 11 February**
It crosses the Hungarian-Yugoslavian border
- 6 13 February**
The plume reaches Belgrade, (Perlez), Yugoslavia.
- 7 15 February**
It meets the Romanian border again, at Ram.
- 8 17 February**
Cyanide shows up in tests at Iron Gate, Romania.
- 9 25-28 February**
The plume reaches the Danube Delta.

The contaminated spill travelled into the rivers Sasar, Lapus, Somes, Tisza and Danube before reaching the Black Sea about four weeks later. Some 2,000 kilometres of the Danube's water catchment area were affected by the spill.
